UPPER OWL CREEK DAM

NDS No. PA-00673

**PHASE I INSPECTION REPORT
NATIONAL DAM INSPECTION PROGRAM**

BY
Berger Associates, Inc.
Harrisburg, Pennsylvania
FEBRUARY 1979

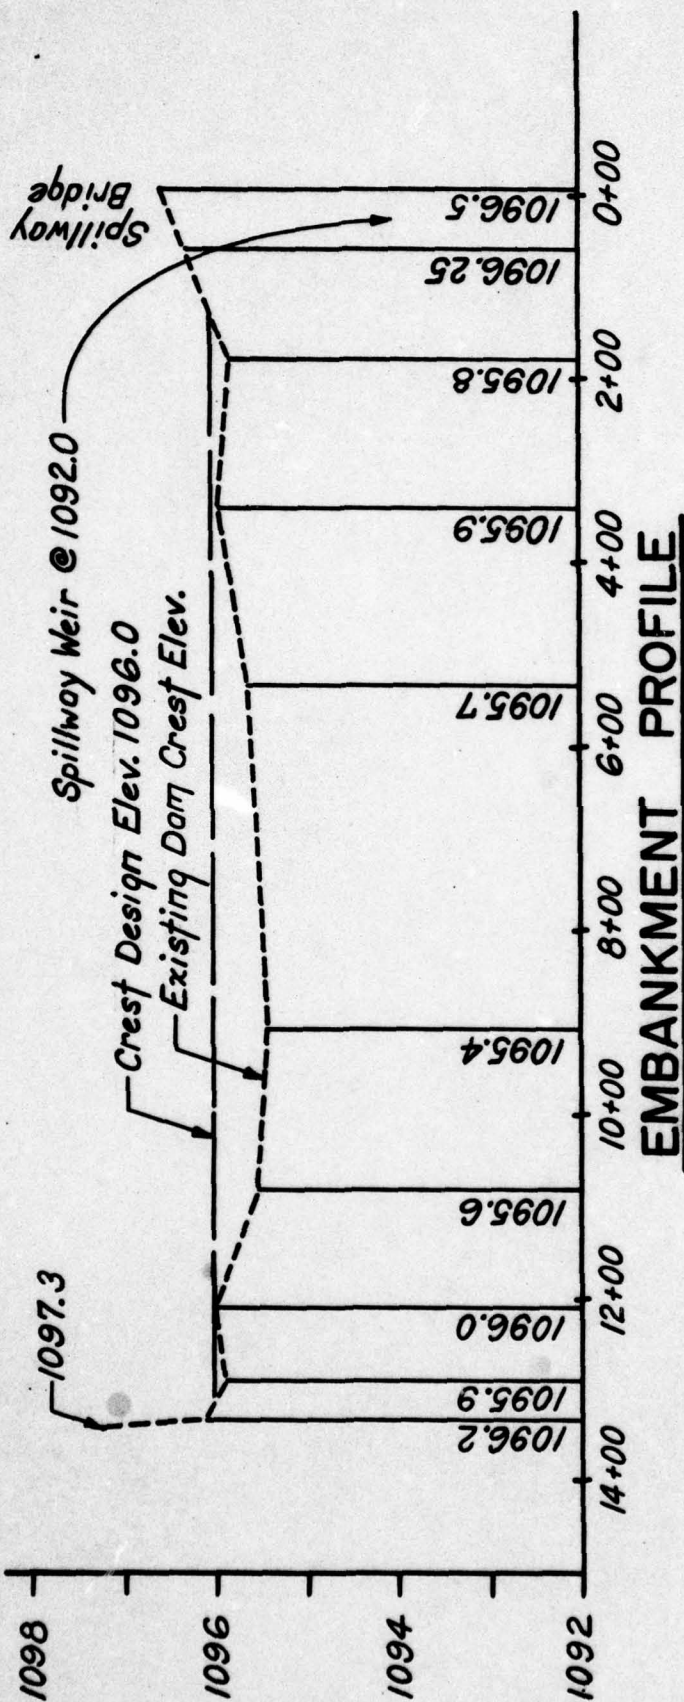
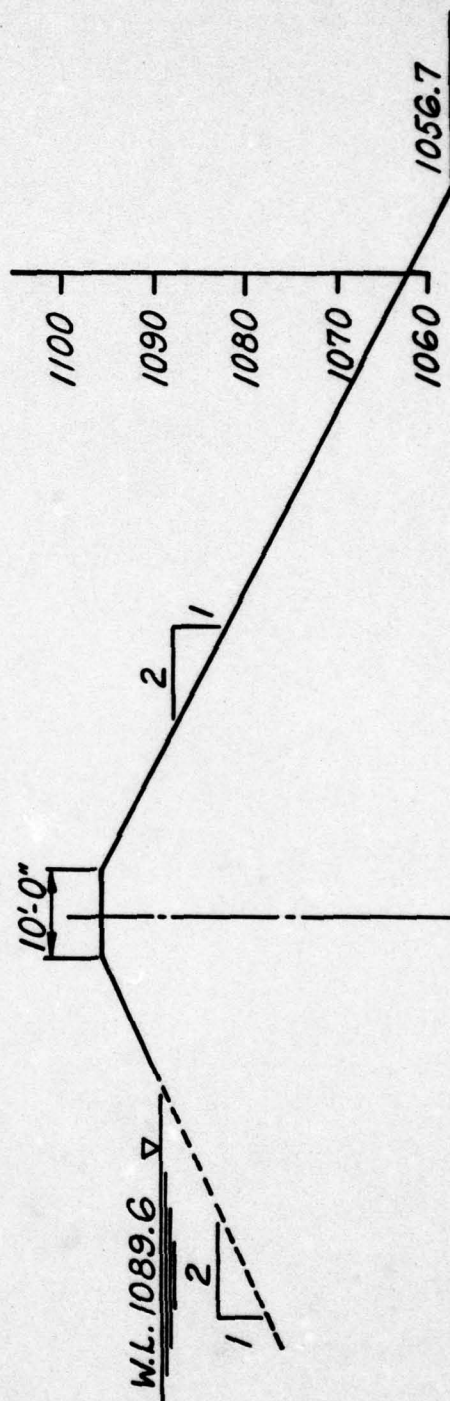
PLATE A-I

The upstream slope of the embankment is protected by riprap and was in good condition. Some riprap had been displaced by ice action but at present this would not affect the integrity of the dam. The grassed breast of the dam was in good condition. The horizontal alignment was good and the width of the dam was regular and approximately 10 feet wide. The original drawing calls for a spillway weir at 5.0 feet below the top of the dam. The inspection survey indicates that the difference is, in general, less than 4.0 feet and at the low spot only 3.4 feet. Refer to Schematic Profile in Appendix A.

The inspection survey shows an uneven profile of the embankment crest. Refer to Plate A-I in Appendix A. While this condition does not affect the stability of the embankment, providing an uniform elevation at the design crest level will improve the overall capacity of the facility.

1. The top of the dam should be raised uniformly to its intended design height.
2. Access into the intake tower should be provided.
3. The condition of the upstream drawdown gate should be closely examined by a qualified professional engineer.
4. The seepage condition beyond the toe of the embankment should be evaluated by a qualified professional engineer. If remedial measures are necessary, they should be carried out by the owner.
5. The downstream embankment slope and the spillway discharge channel should be cleared of brush and trees.

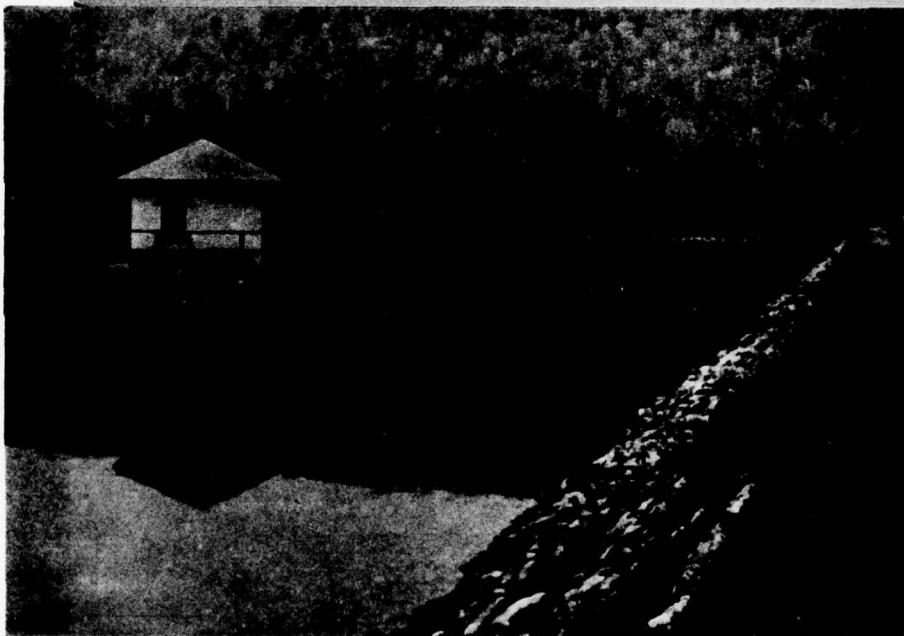
The intake structure is a circular concrete tower, accessible by a footbridge from the breast of the dam. Some spalling of the concrete at the waterline had occurred due to normal weathering and ice action. The door leading to the inside was locked and no keys were available.

Upstream Embankment
and
Intake Structure

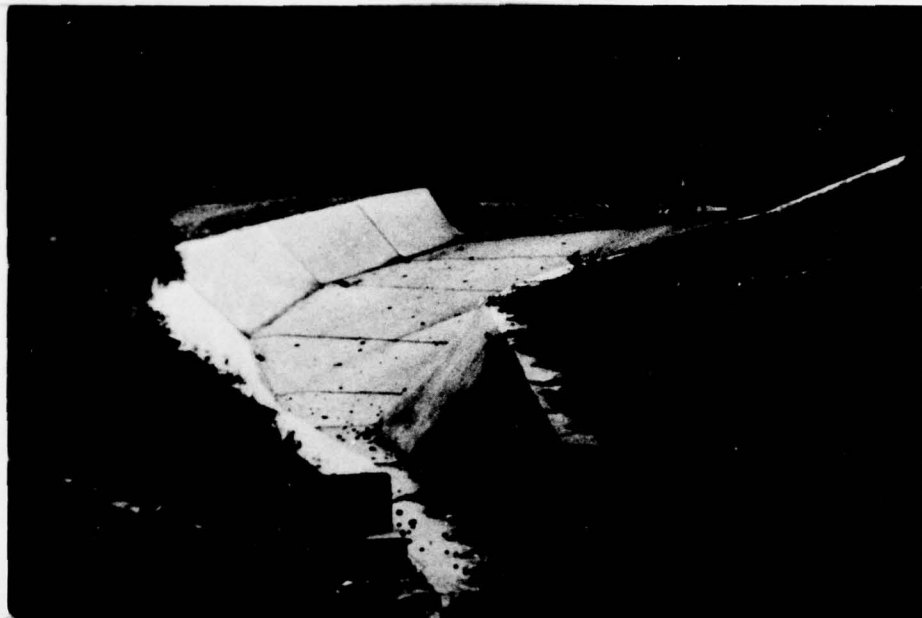
The intake structure and valve house are in reasonably good condition, although the inside of the intake structure could not be observed. There were no indications of unstable conditions. The spillway weir and top section of the spillway are in good condition. The stone lined spillway chute was in excellent condition, but appears to be too small.

Spillway Chute
